## 4B GROUP

### Flour Mill

State of the Art Hazard Monitoring  
for State of the Art Flour Mill

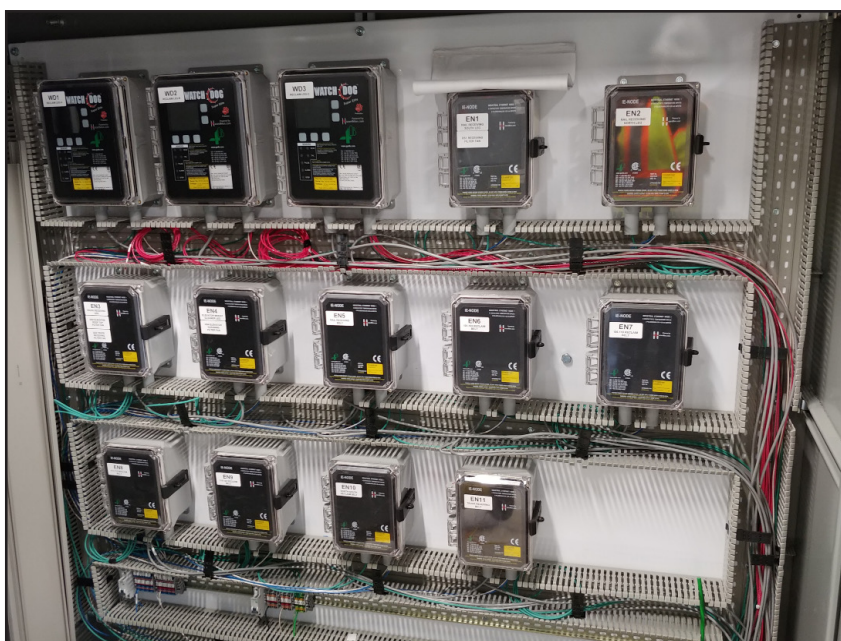
*Panel of IE-Nodes*

4B's newest hazard monitoring system, the Industrial Ethernet Node (IE-Node) was the perfect fit. It features EtherNet/IP

communications that work directly with the customer's Allen Bradley PLC without any gateways while being approved for Class II, Division 1 Group E, F & G hazardous dust environments. It provides inputs for continuous bearing temperature sensors, belt alignment sensors, and speed sensors. The customer selected the IE-Nodes because they are technologically superior to other options on the market and improve the flexibility of installation all at an attractive price. The IE-Nodes each have 10 inputs and can be expanded to 16 to provide even more flexibility in applications where the site needed additional sensors. All of the sensors can be fully tested with 4B's Speedmaster and ADB Tester and the system has the unique ability to have multiple speed inputs for the PLC to monitor the speed ratio on equipment operating with VFDs. The customer selected NTC Adjustable Depth Bearing (ADB) temperature sensors, 2" x 4" rectangular brass rub blocks with stainless steel hinged inspection doors for belt misalignment, and whirligigs with 4-20 mA Milli-Speed sensors for monitoring belt slippage. 4B provided training for both the end user and installer to highlight the best practices for wiring and maintaining the system.
